INVENTORY FORM FOR STATE HISTORIC SITES SURVEY

NAME				
HISTORIC				
Anderton		•		•
AND/OR COMMON				
	<u></u>			
LOCATION				-
STREET & NUMBER				
	.5 miles west of O	twell Rd (nor	cth)	
CITY, TOWN	.) miles west of o	CWETT MG. (1101	CONGRESSIONAL DIST	RICT
Oxford		VICINITY OF		
STATE			COUNTY	
Maryland			Talbot	
CLASSIFIC	ATION	:		
CATEGORY	OWNERSHIP	STATUS	PRES	SENT USE
DISTRICT	PUBLIC	X .OCCUPIED	AGRICULTURE	MUSEUM
XBUILDING(S)	X PRIVATE	UNOCCUPIED	COMMERCIAL	PARK
STRUCTURE	вотн	WORK IN PROGRESS	EDUCATIONAL	X.PRIVATE RESIDENCE
SITE	PUBLIC ACQUISITION	ACCESSIBLE	- <u></u> ENTERTAINMENT	RELIGIOUS
·OBJECT	IN PROCESS	YES: RESTRICTED	GOVERNMENT	SCIENTIFIC
	BEING CONSIDERED	YES: UNRESTRICTED	_INDUSTRIAL	TRANSPORTATION
		Ϫno	MILITARY	OTHER
NAME Mr. & Mrs STREET & NUMBER	William Anderson		Telephone #: (3	01) 822-1767
Anderton				
CITY, TOWN				zip code
Oxford		VICINITY OF	Maryland 21654	
LOCATION	OF LEGAL DESCR	IPTION	Liber #: 255	
COURTHOUSE.	-		Folio #: 273	
REGISTRY OF DEEDS,	^{ETC.} Talbot County C	ourthouse		·

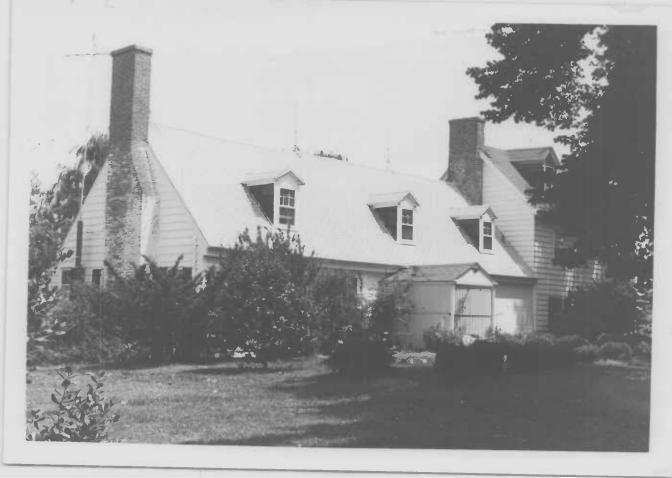
photographed by doctorn T-155 michael Braine Anderton Talbot County, Maryland T-155 Neg. located at the Trust, July 1976 Photographed from southwest. $1\frac{1}{2}$ -story section with brick end chimneys. West section built 11/2 story section with brick ena chimneys. West section built 10 1930.

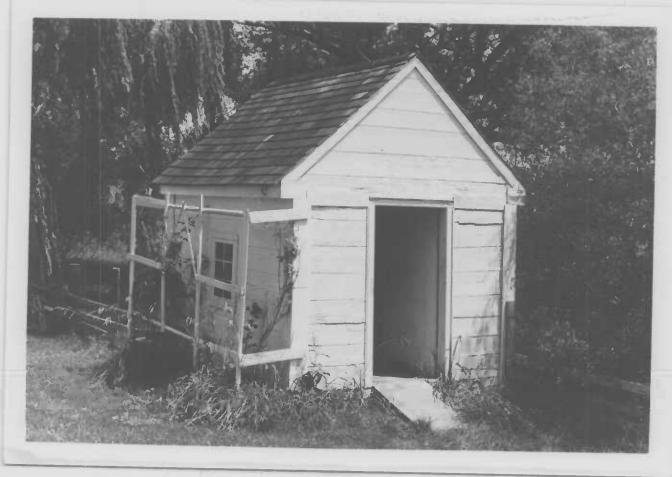
Anderton T-155 Telbot County, Maryland Neg. located at the Trust, July 1976 Small frame outbuilding with gabled roof. of outbldg. #3) Small frame authoriding

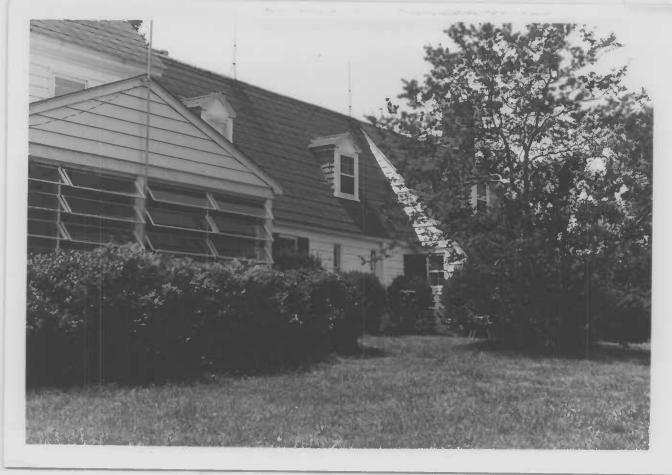
photographed by michael Bourne Anderton T-155 Talbot County, Maryland July 1976 Neg. located at the Trust, July 1976 Photographed from northeast. South (main) facade containing central entrance. To the left of this photo is a small porch 2 of #2) photographed from north East south (main) facade confaining central entrance. To the left of this whole is a small porch.
